Highwall Rockfall Incident: Excavator Operator Injury

28 July 2024 | North Pit, Section A

This safety alert details a serious rockfall incident that occurred following blasting operations. The event highlights critical safety considerations for operations near highwalls, particularly after blasting and during periods of heavy rainfall.

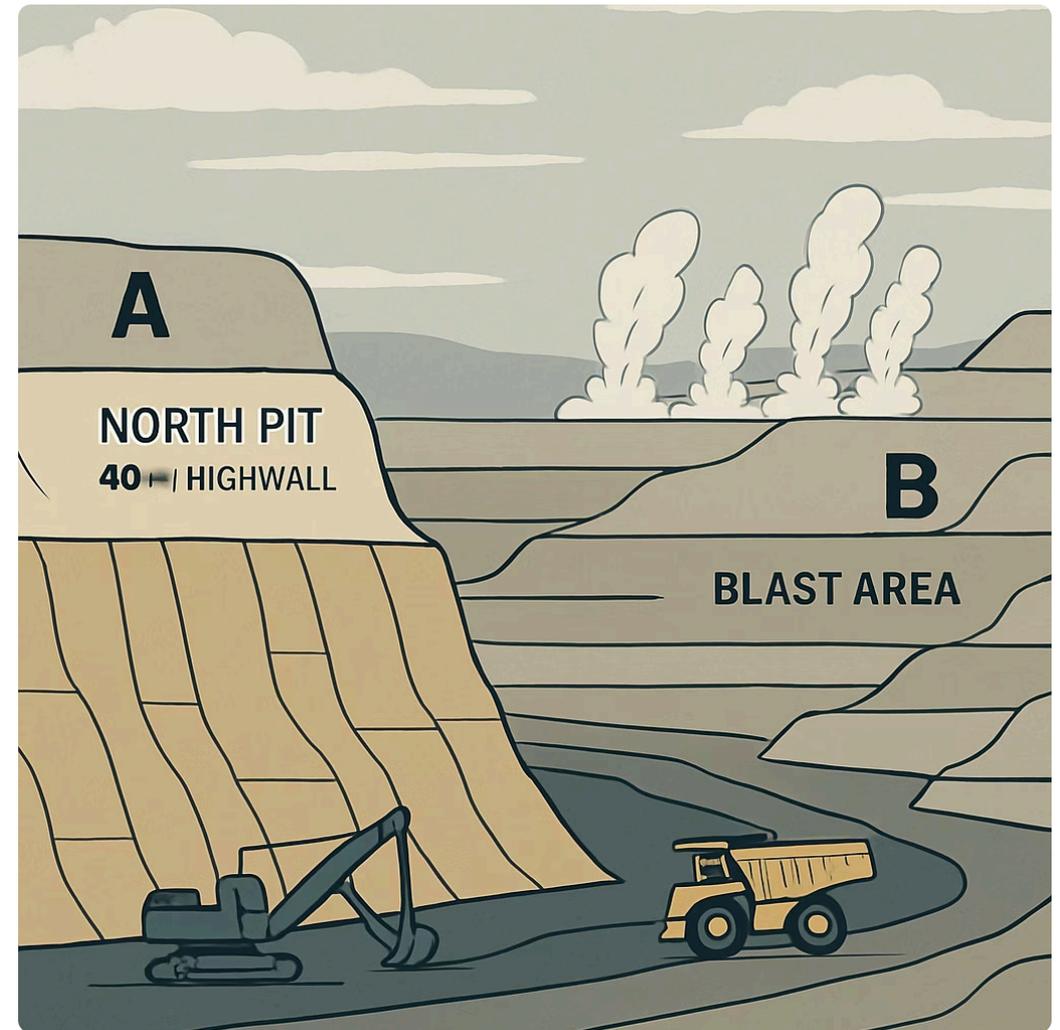
- North Pit, Section A of an open cut coal mine
- 40-metre highwall collapsed
- Adjacent to Section B where blasting had occurred
- Approximately 30 metres between blast area and incident location

⚠ The proximity of blasting operations to active work areas created a significant hazard that was not adequately assessed or communicated.

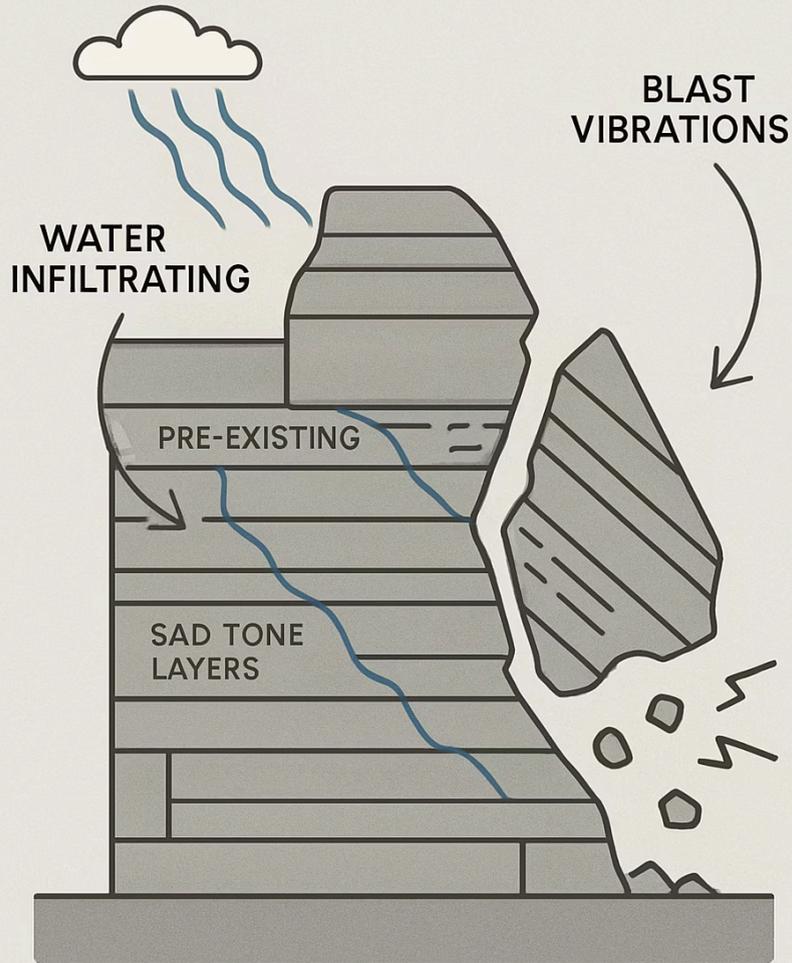
HIGHWALL CROSS-SECTION

Water infiltrating along pre-existing discontinuities

The rockfall resulted from a planar failure along discontinuities in sandstone layers within the highwall structure.

Approximately 150mm of rainfall in the week prior had created lubricated planes of weakness within the rock mass.

Vibrations from the adjacent section triggered the failure of the already compromised highwall structure.

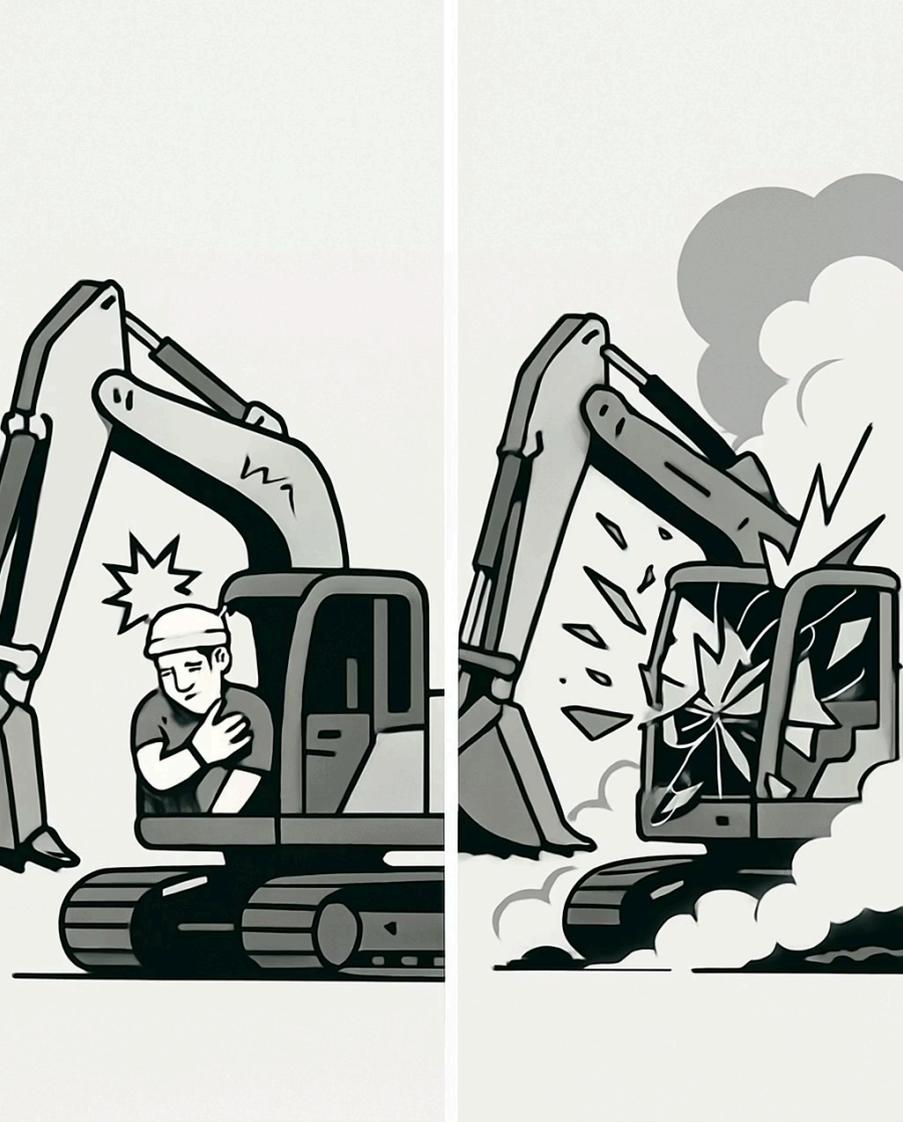
Catastrophic cabin damage

- Fatal injuries if rockfall had directly impacted the operator cabin
- Catastrophic equipment loss
- Extended production disruption
- Regulatory investigation and potential penalties
