Incident: Rockfall - Demo - 2602

Description: On July 28, 2024, a rockfall occurred in North Pit Section A, causing minor injuries to an excavator operator and significant equipment damage after a nearby blast.

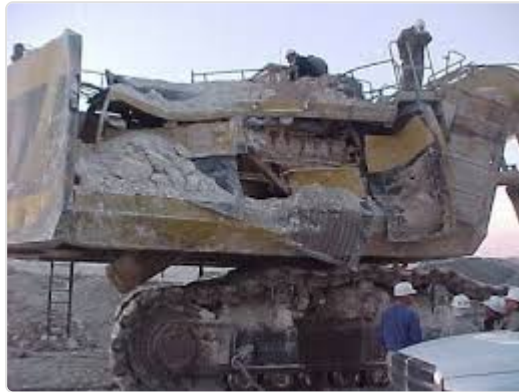
Title: Damaged mobile plant with personnel present

Description: Tracked excavator on sandy ground with multiple people positioned around the machine. Equipment shows visible damage and discoloration. Appears to be post-incident assessment or recovery operations consistent with emergency response described in evidence.

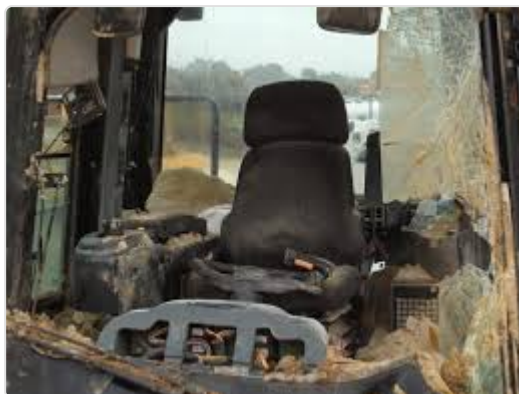
Image 1

Title: Damaged mobile plant operator cabin interior

Description: Interior view of excavator cab showing operator seat and controls with front windscreen area displaying irregular jagged opening. Visible dirt accumulation and damage to cabin structure. Consistent with rockfall impact damage described in incident evidence.

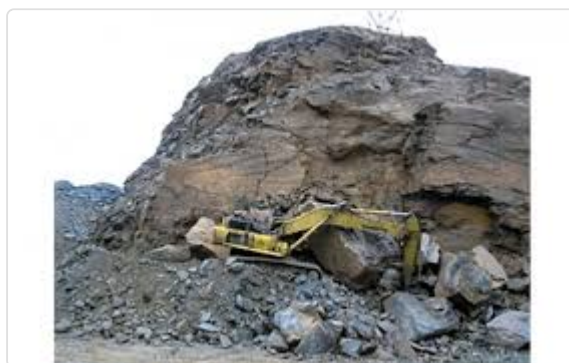
Image 2

Title: Mobile plant operating at base of highwall

Description: Yellow tracked excavator positioned at base of layered rock face with loose debris scattered around work area. Highwall shows exposed sedimentary strata with near-vertical face. Consistent with North Pit excavation operations described in evidence.

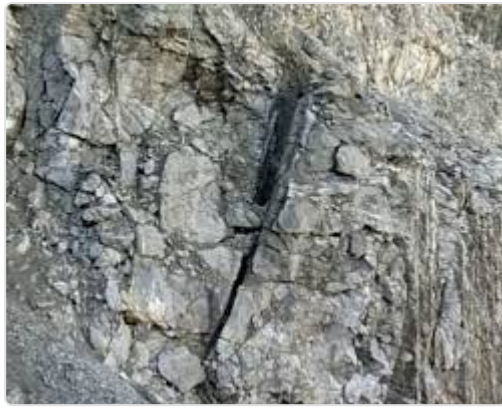
Title: Rock surface with visible cracks and fractures

Description: Close-up view of gray rock surface showing multiple cracks including a prominent diagonal fracture and network of smaller hairline cracks. Angular fragments and rough granular texture visible throughout. Link to incident evidence is unclear.
