Highwall Rockfall Incident: Excavator Operator Injury

28 July 2024 | North Pit, Section A

This safety alert details a serious rockfall incident that occurred following blasting operations. The event highlights critical safety considerations for operations near highwalls, particularly after blasting and during periods of heavy rainfall.

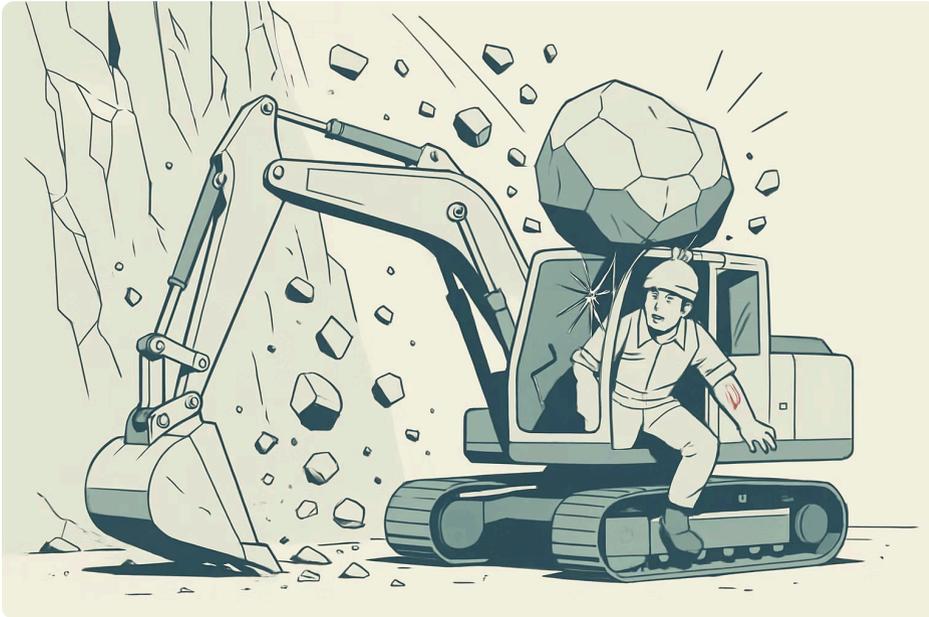
1

- A rockfall occurred from a 40-metre highwall in an open cut coal mine
- The falling material struck an excavator working in the area
- The operator sustained a sprained ankle and bruises whilst exiting the machine
- The incident occurred shortly after blasting operations in an adjacent section

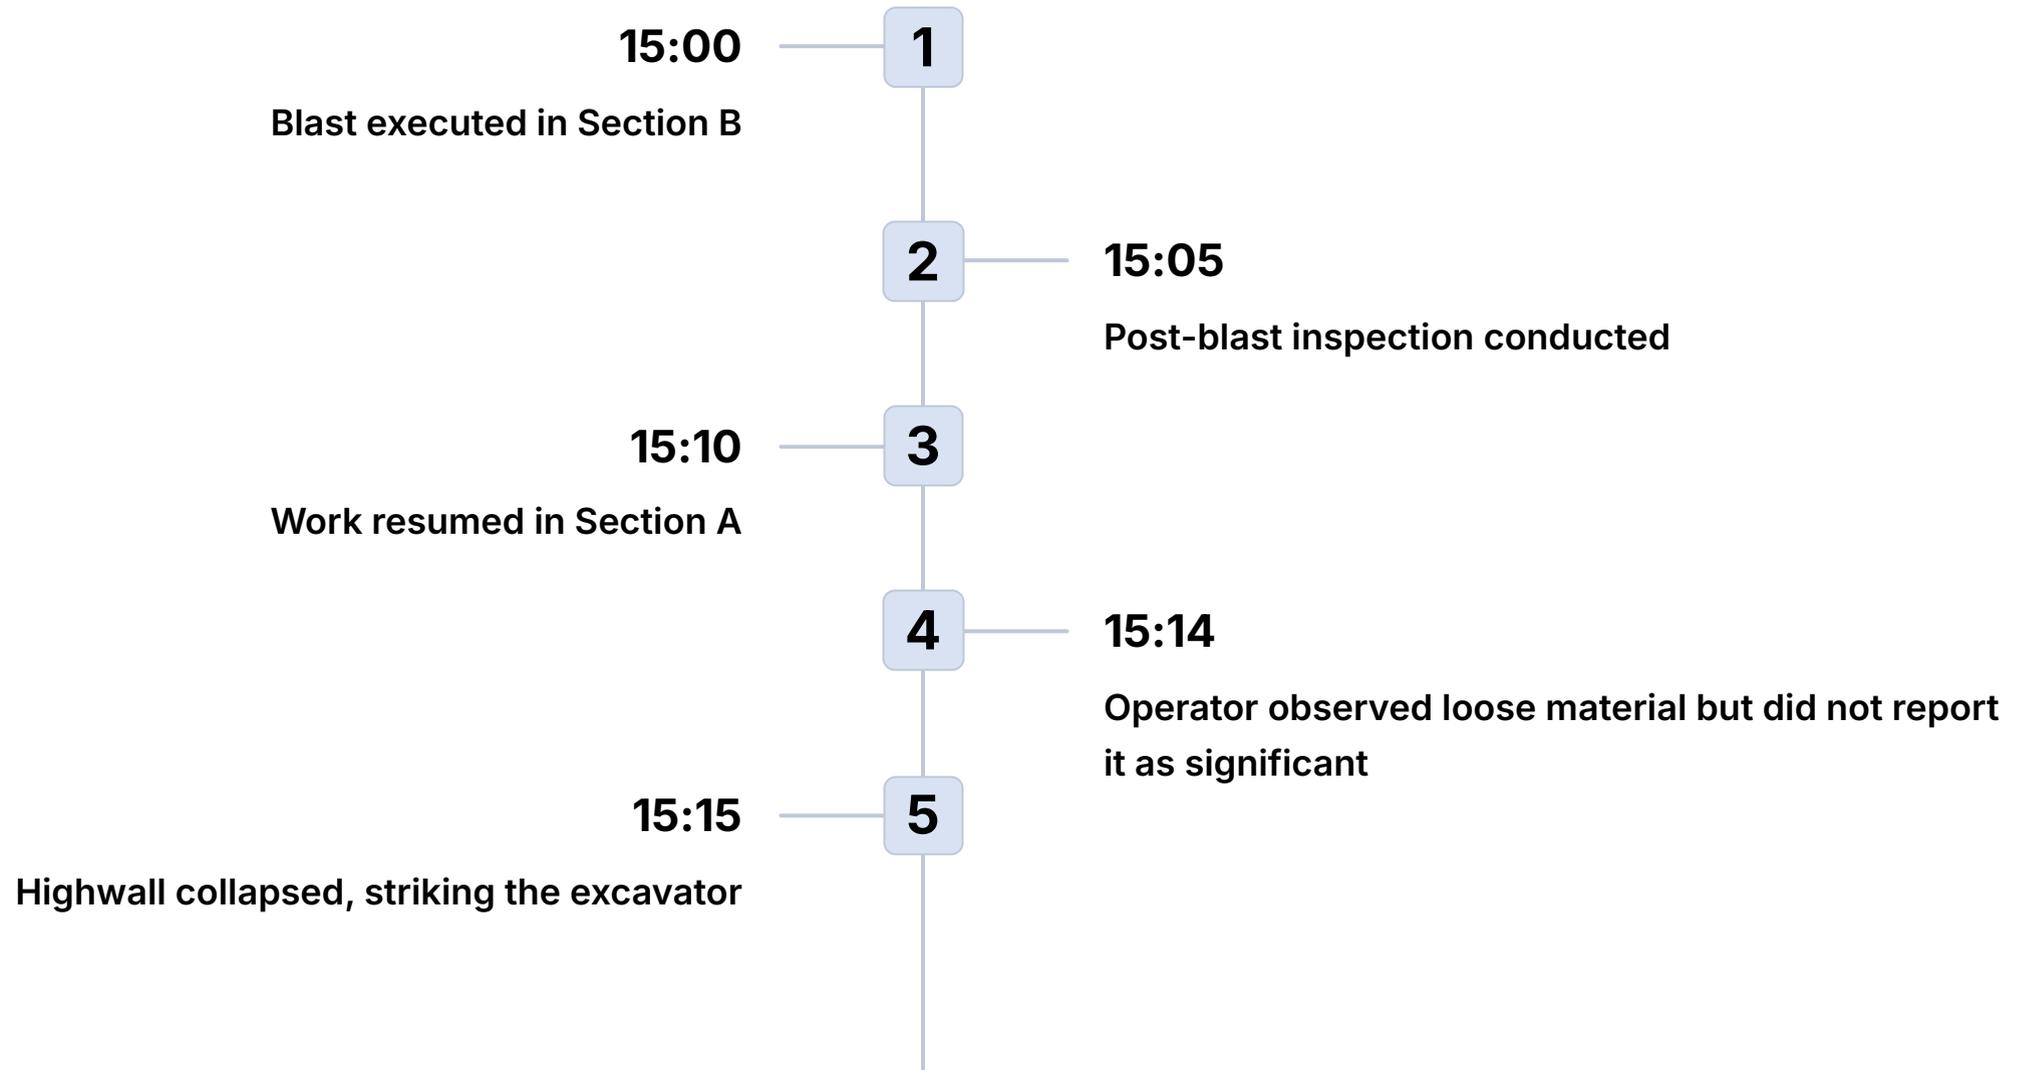
Only 15 minutes elapsed between the blast and the rockfall, with just 5 minutes between work resumption and the incident.
